# Scuppernong Springs and Paradise Springs

## Spring gaging station - Installation report

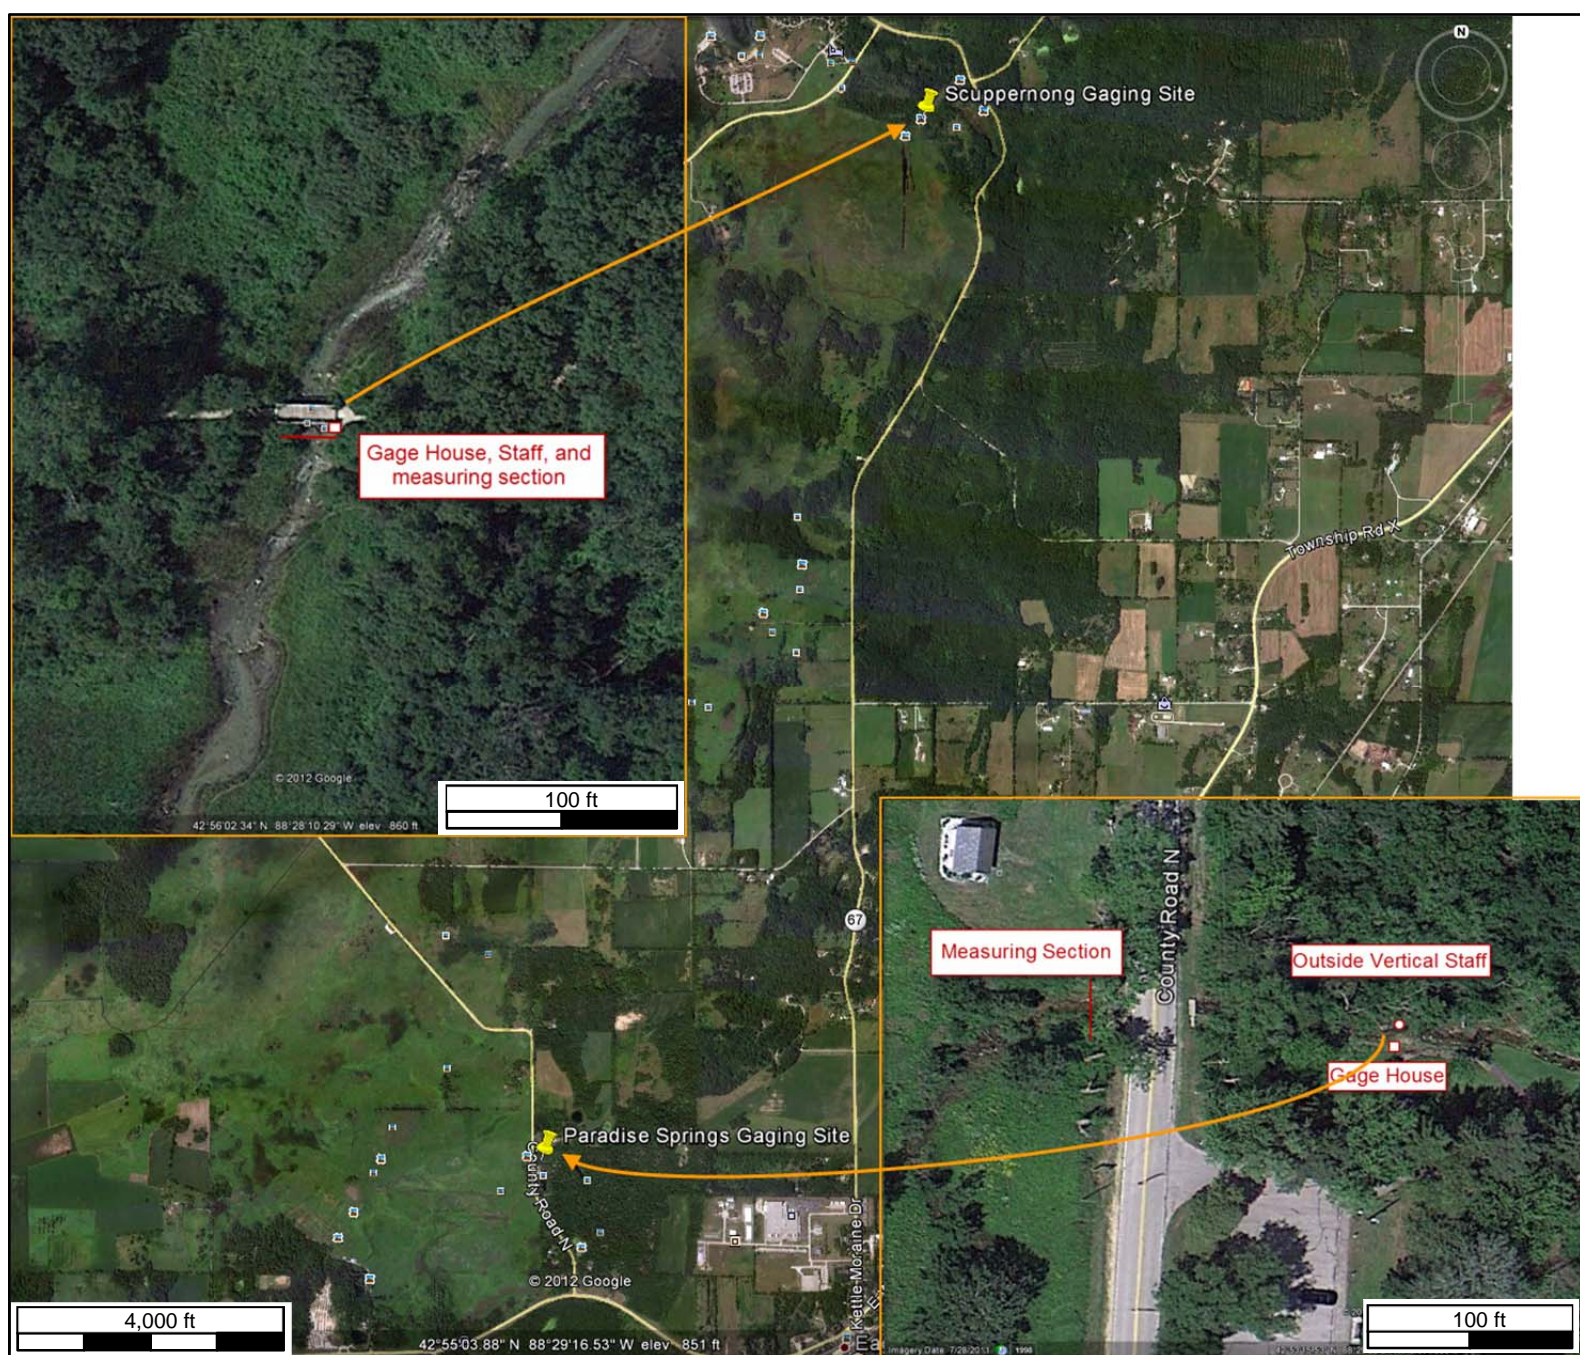
Figure 1: Overall site map with inset maps for each site location.

A map of the location of each spring monitoring station is included in Figures 1 and 2 (pages 2 and 3). A series of photos taken by the USGS after installation activities are included on pages 4 to 6.

Following installation, the USGS will continue to perform periodic manual flow measurements near the gaging stations (see reference to “Measuring Section” in Figure 1). The exact location of the Measuring Section may change depending on measurement results, vegetation, and the location of debris. By performing manual flow measurements and recording water levels, a rating curve will be developed and calibrated for flow in each creek. The USGS will then use these rating curves to estimate flow in the creek at any point in time based on the water level measured in the creek.

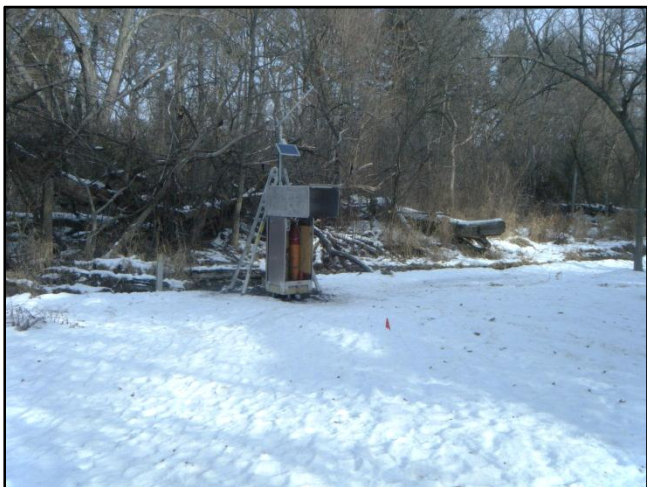
Gaging Station installed Jan 2013 along creek bank

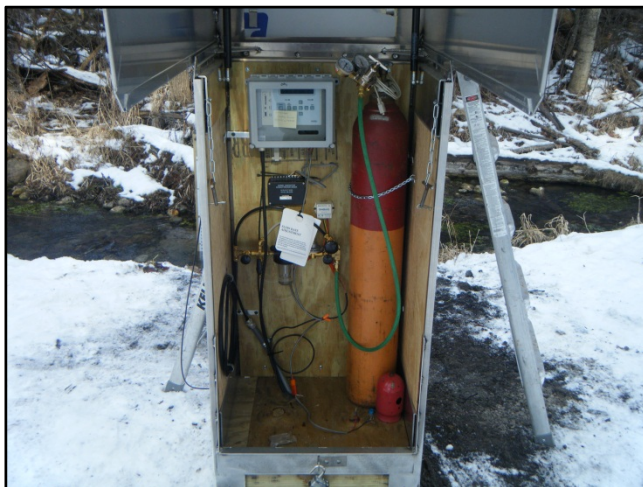
Nitrogen tank, pressure transducer, datalogger, and telemetry equipment inside the gaging station

Water levels in the creek are continuously measured by back pressure on the orifice line. The back pressure is a function of the pressure exerted on bubbles of nitrogen gas which slowly bleed out the end of the orifice line. The higher the water level, the higher the pressure exerted on the bubbles of nitrogen gas, and therefore the higher the pressure reading by the pressure transducer. Measurements by the pressure transducer are then recorded on the datalogger and relayed to the USGS database via the antenna. The tank of nitrogen gas, pressure transducer, datalogger, and telemetry equipment is securely located inside the gage house.

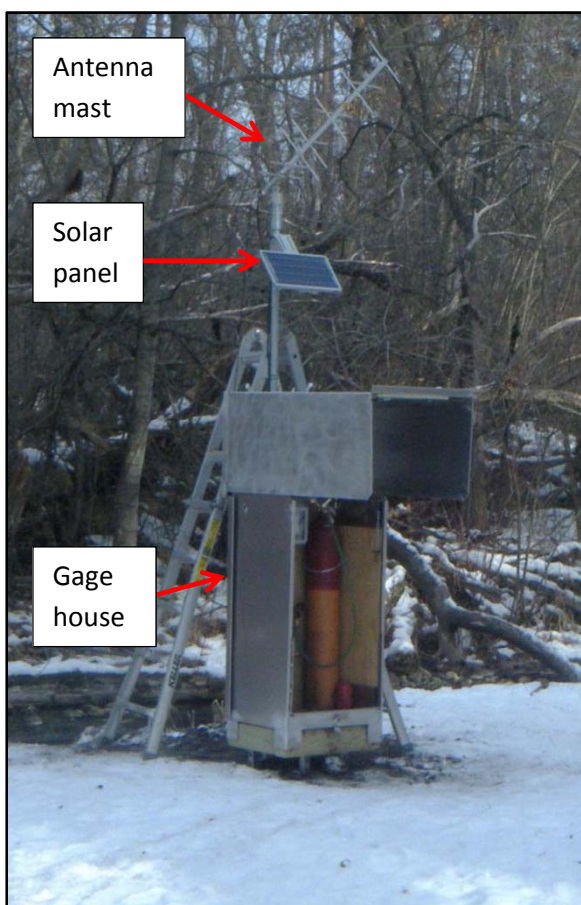
Close up of gaging station (looking northeast).

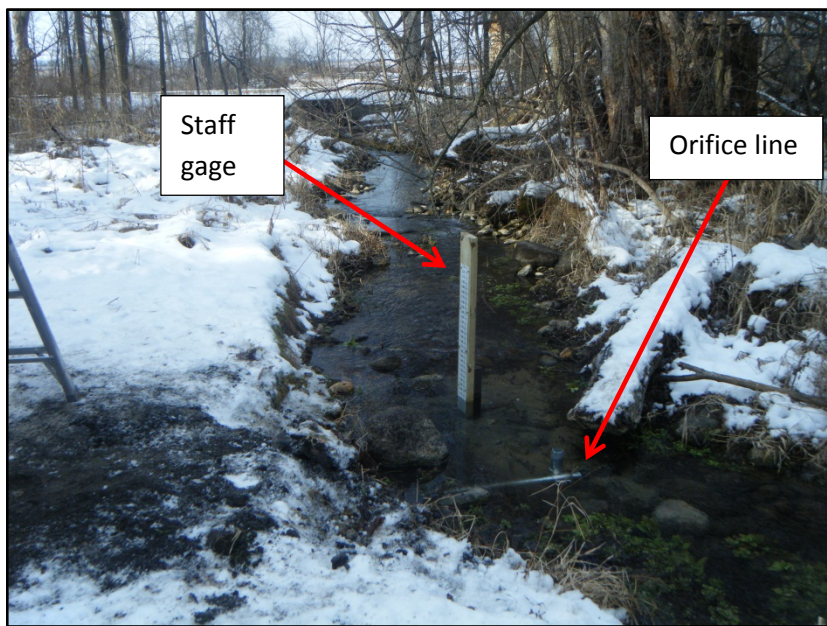
Staff gage and orifice line in creek (looking downstream to the east).  
Gage house is out of view to the left.

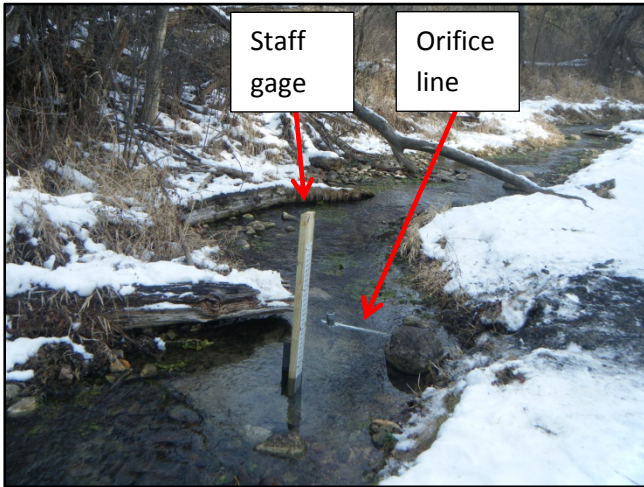
Staff gage and orifice line in creek (looking upstream).  
Gage house is out of view to the right.

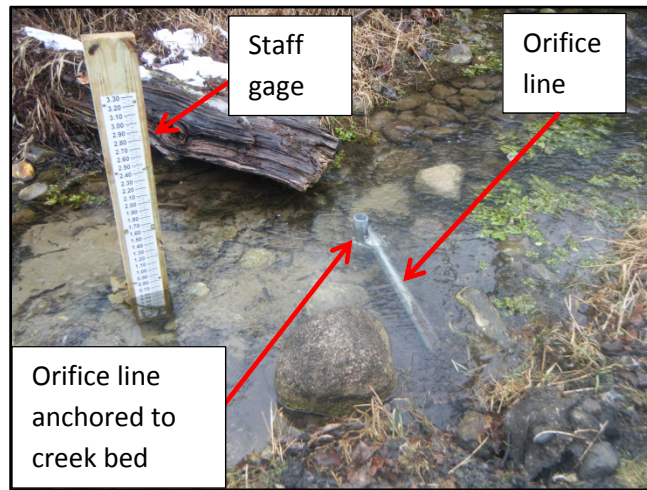
Staff gage and orifice line in the creek (looking north with  
back to the gage house).

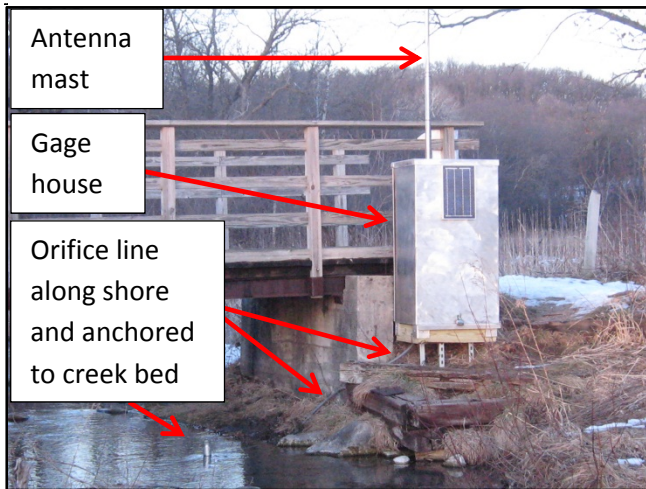
Gaging station looking upstream (looking north-northeast).

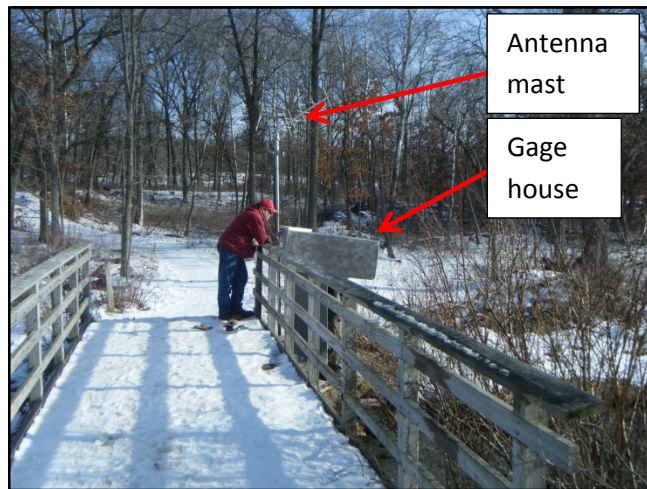
Side view of gage house and antenna mast (looking east)  
Front door of gage house is open.

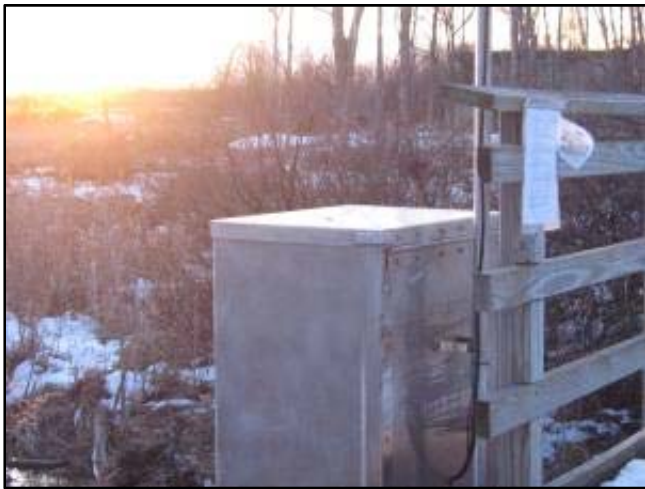
Rear of gage house (looking southwest).

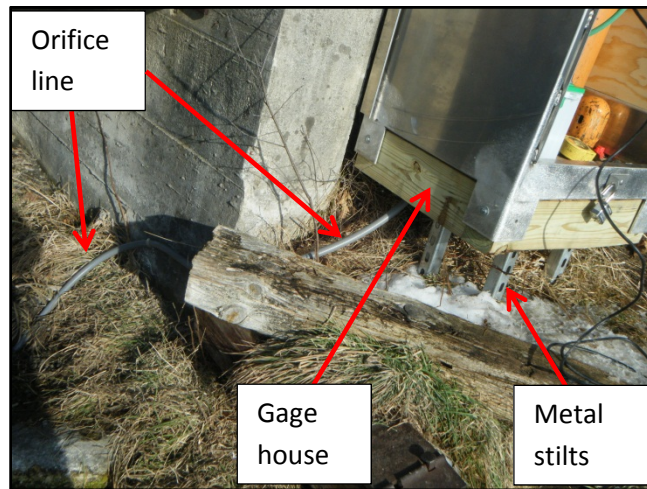
Front of gage house with orifice line running down bank to creek. Gage house installed on metal stilts.

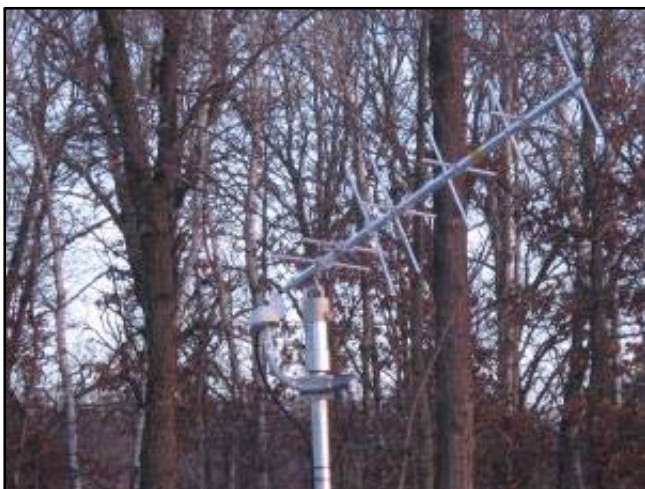
Close-up of antenna mast.

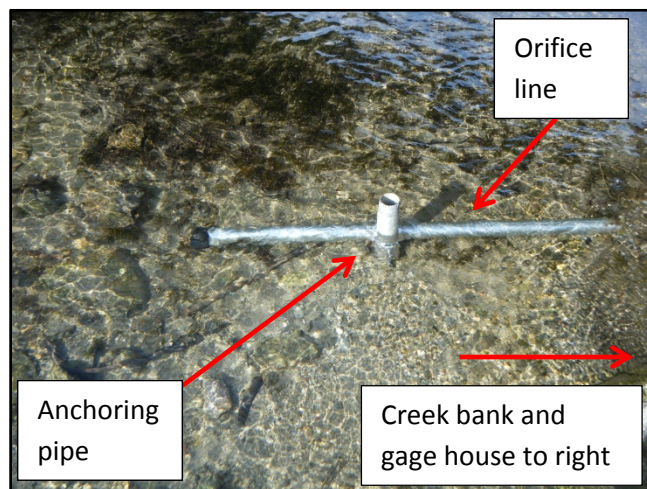
Orifice line anchored to the creek bed.
